**CORROSION OF GALFAN IN SOIL AND CONCRETE
PROJECT #ZM-428**

2001 PROGRESS REPORT

**CORROSION TESTING LABORATORIES, INC.
60 Blue Hen Drive
Newark, DE 19713**

February 2001

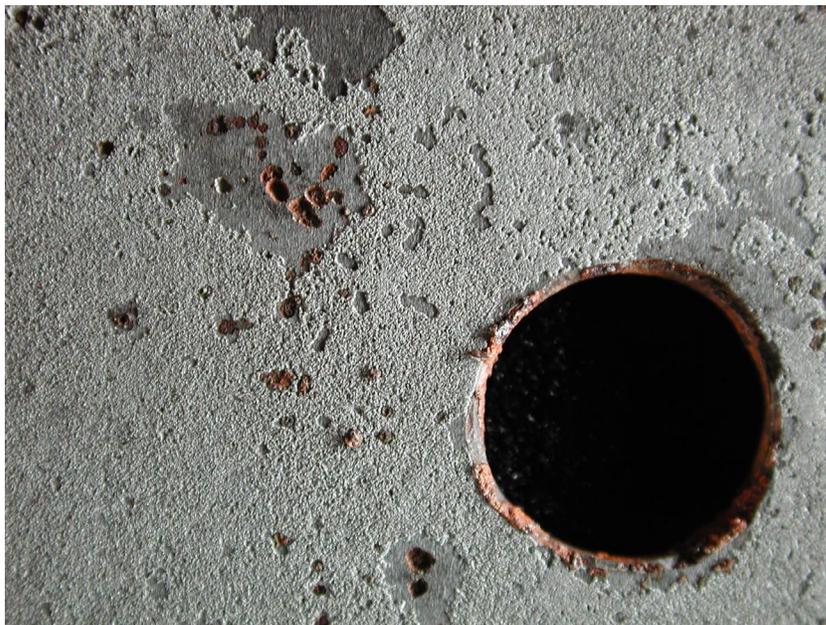
In general, the Galfan-coated specimens appeared less corroded than the galvanized specimens retaining 70–90% of the GF115 coating and 85-95% of the GF200, however the GF200 coating appeared to have areas that had pitted (Figure 1). The galvanized 3" × 3" specimens had a heavily corroded appearance with large patches of red rust and only traces of galvanizing left on the G115 specimens and 35-40% of the coating on the G200 specimens.

Figure 1 Pitting observed on a 3" × 3" Galfan 200 specimen removed from the Montreal Site after approximately eight years of soil exposure

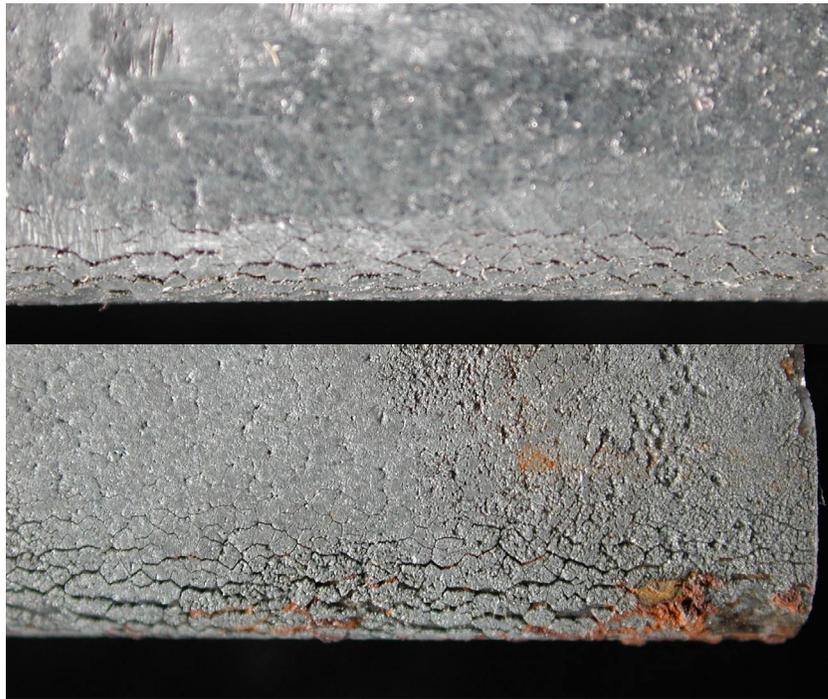
The Galfan-coated specimens had some patches of red rust concentrated near bent and cut edges. Although both GF200 and GF115 showed similar corrosion rates, the GF200 specimens performed better visually than the GF115 specimens. The bends appeared to be more susceptible to corrosion due to cracks (Figure 2) observed in the coating.

Figure 2 Cracking observed on outside radius of Galfan 200 Z-Form specimens. The top photo is an unexposed specimen, the bottom was removed from the Montreal Site following approximately eight years of soil exposure
