**SEVENTH GALTAN LICENSEES MEETING**

**Technical Meeting**

**December 5, 1985**

# MINUTES OF THE GALFAN LICENSEES TECHNICAL MEETING

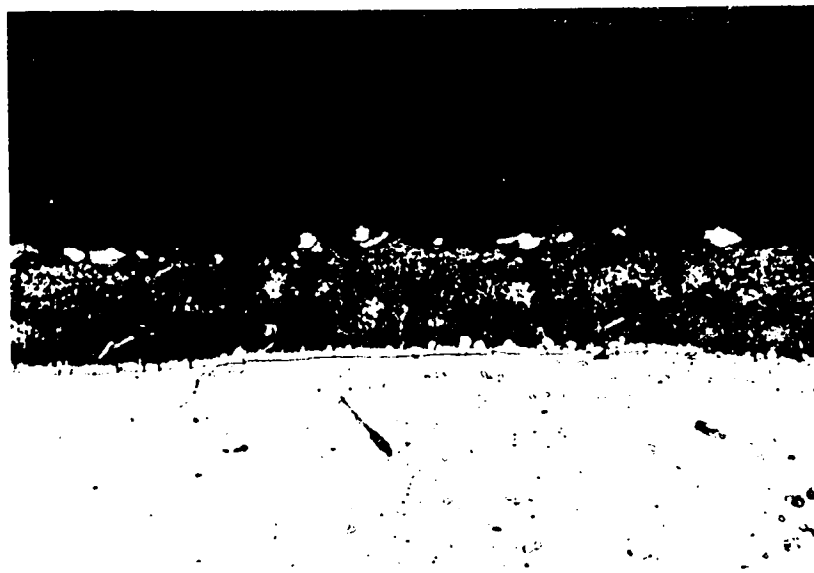
COATING STRUCTURE AFTER ONE YEAR EXPOSURE.

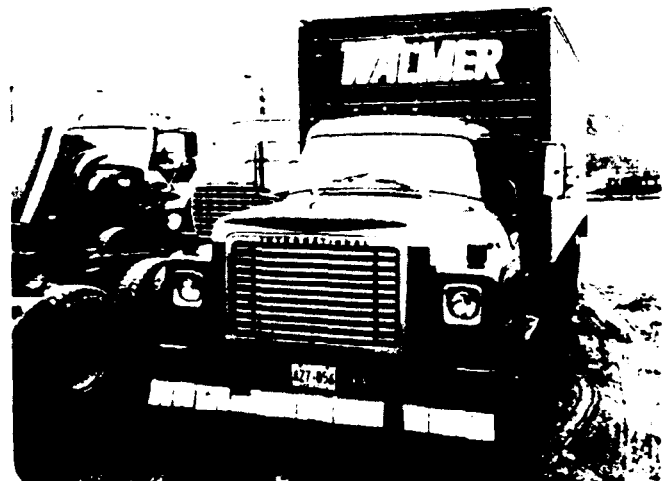
FIGURE 2 - "ON" VEHICLE TEST RACK

The two trucks were each fitted with one 2.15 metre long undervehicle test rack, and one 2.15 metre long front bumper (on-vehicle) rack (Figures 1 and 2).
