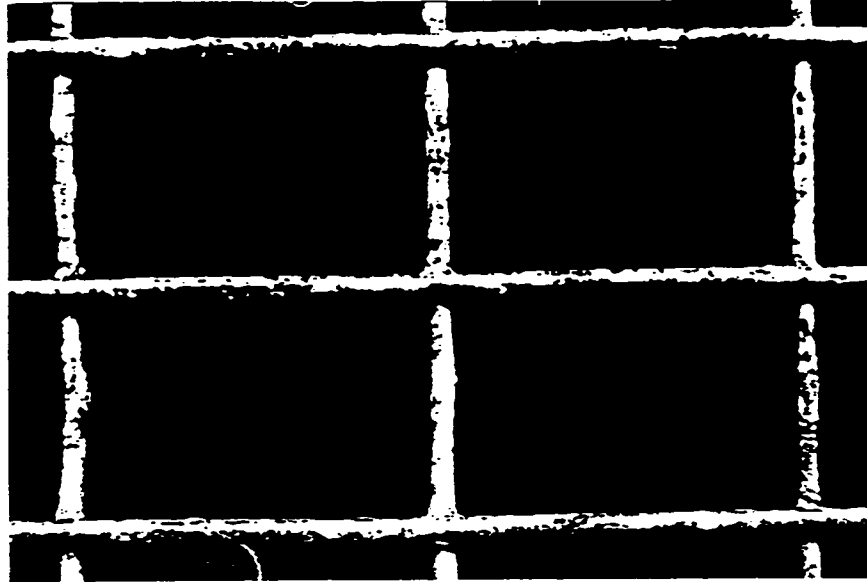
FIGURE 1

Regular galvanized (25 x 40 mm) after 35 cycles  $\text{SO}_2$  – atmosphere testing showing locally heavy corrosion of the weld areas.

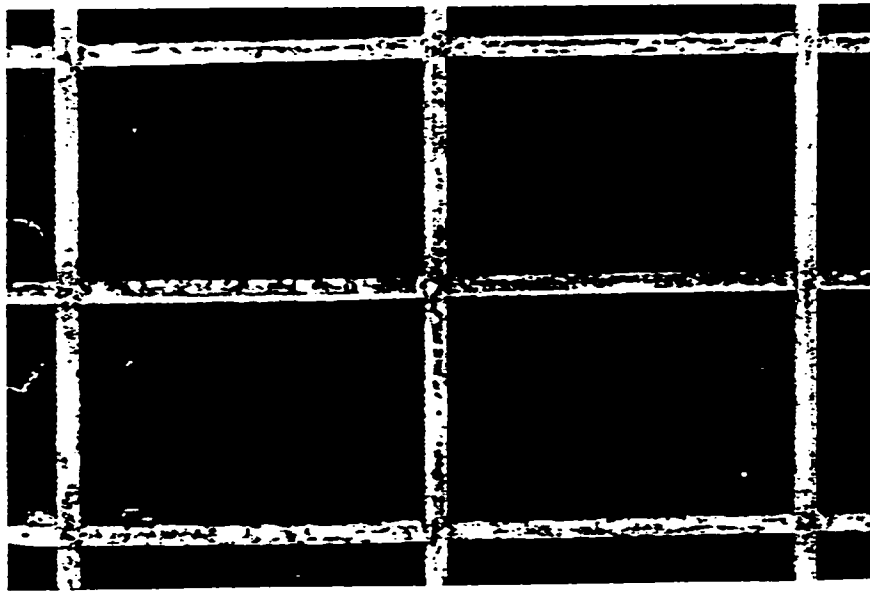
Galfan galvanized (25 x 40 mm) after 35 cycles  $\text{SO}_2$  – atmosphere testing; no significant corrosion attack of the wire or weld areas.

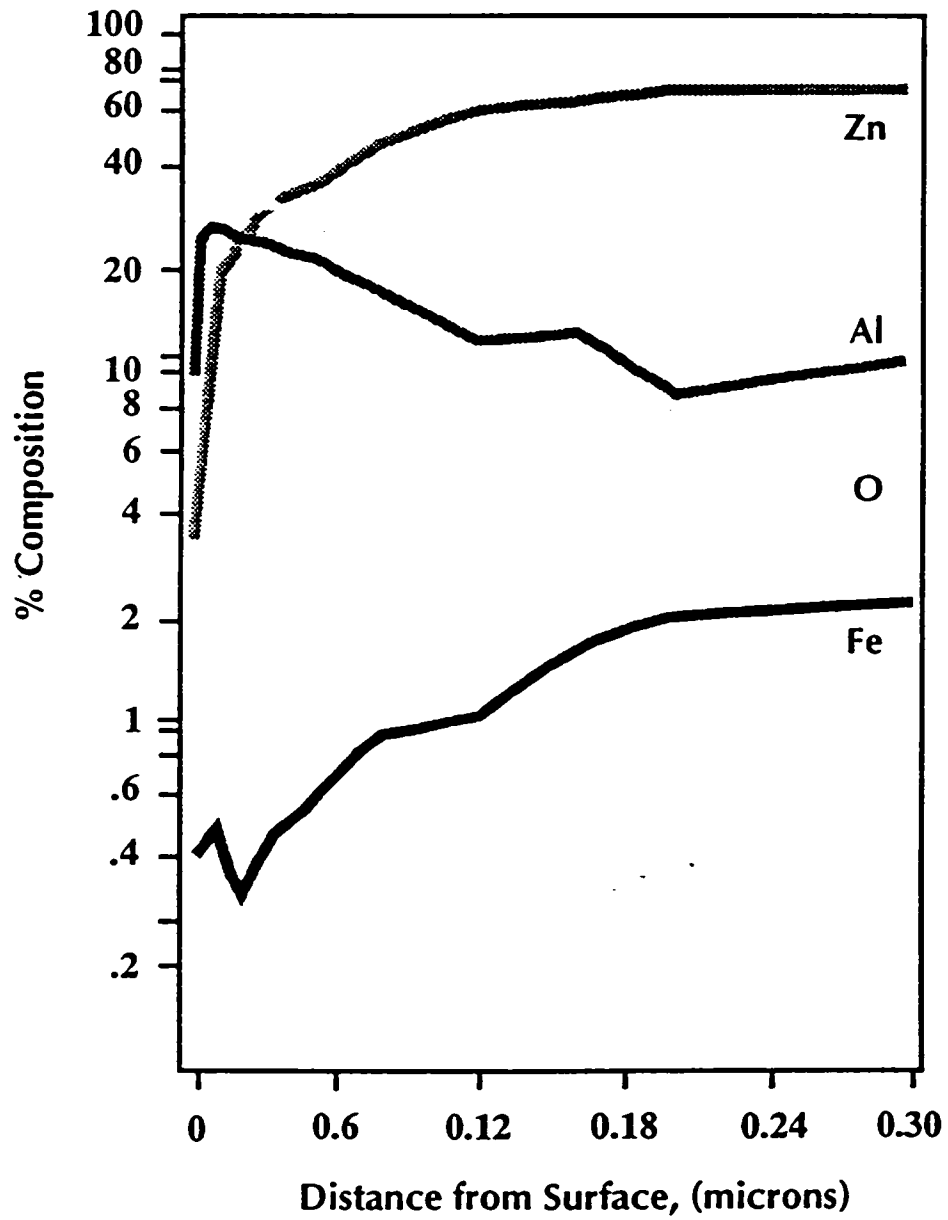
**FIGURE 5**  
**Scanning Auger Microprobe Analysis of Uncorroded Galfan Surface**

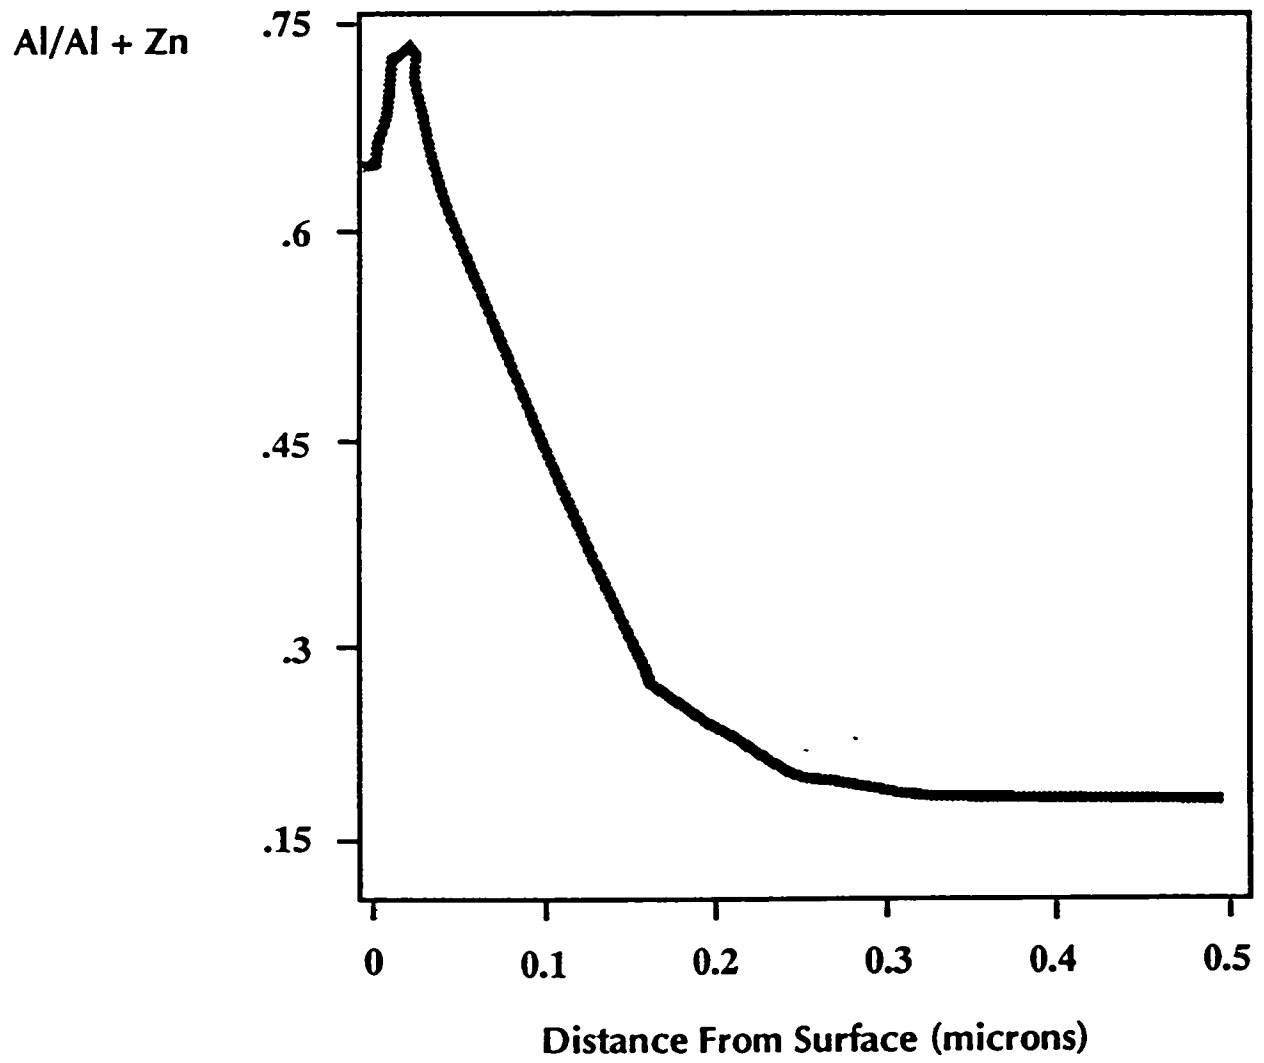
**FIGURE 6**  
**Al-Enrichment of a Corroded Galvan Surface**

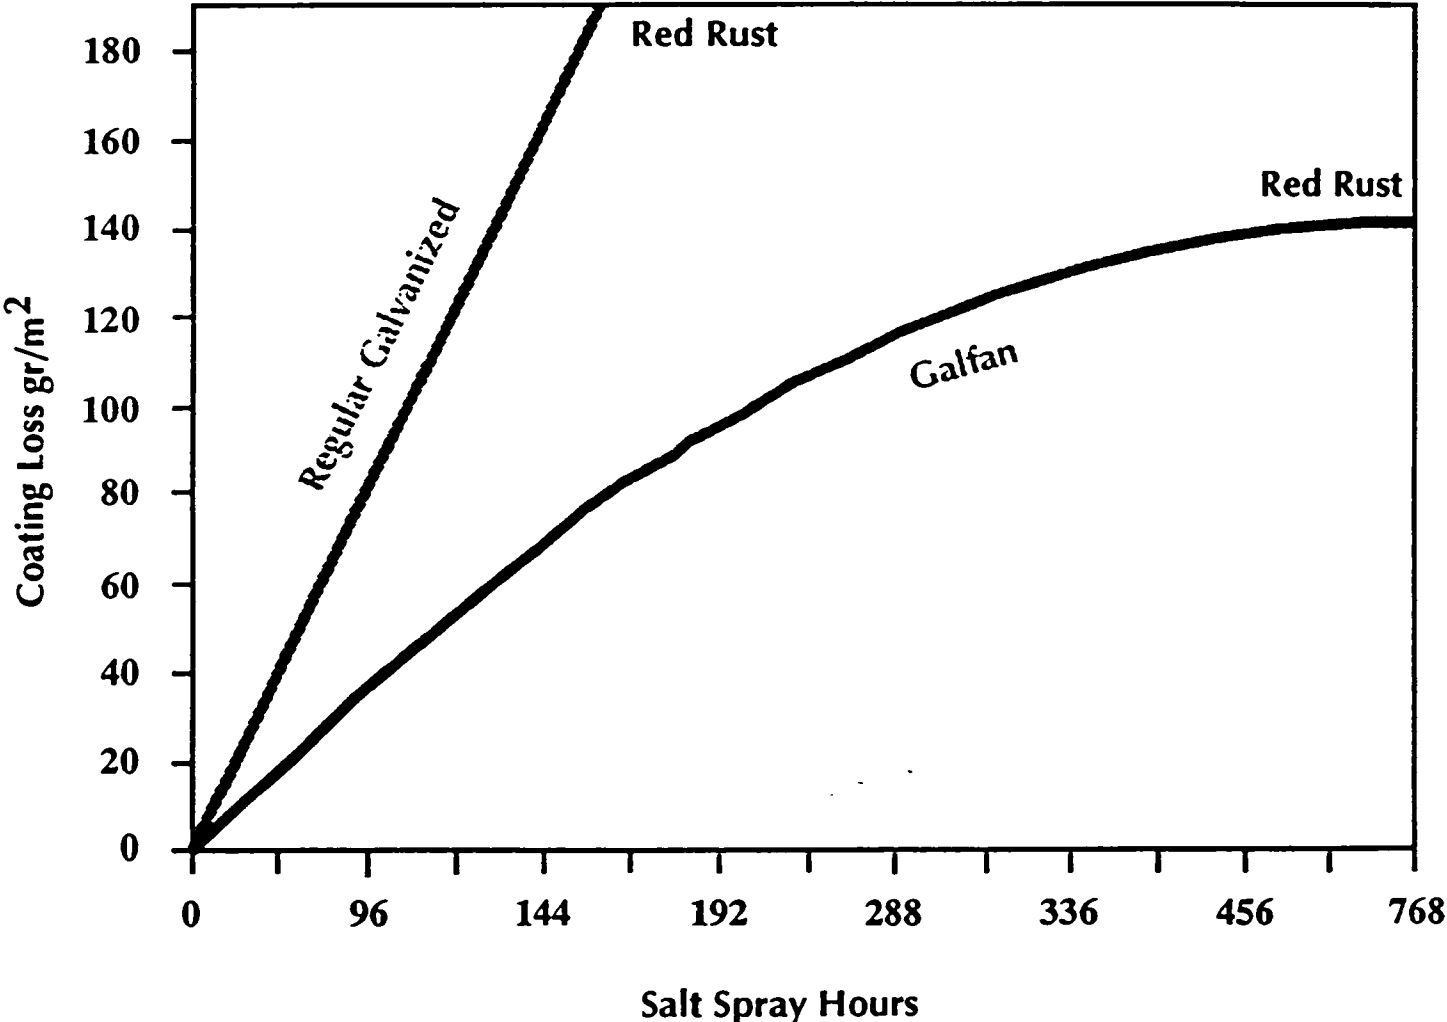
**FIGURE 7**  
**Coating Loss During Salt Spray Test**
