- TO: Galfan® Licensees Galfan Licensee Meeting Attendees
- FROM: John L. Hostetler, P.E., Director Galfan Technical Resource Center
- DATE: 1 February 1993
- SUBJECT: •Minutes of 17th Licensee Meting Proceedings •Preliminary Plans for 18th Licensee Meeting

17th LICENSEE MEETING PROCEEDINGS

17th Meeting

GALFAN LICENSEES

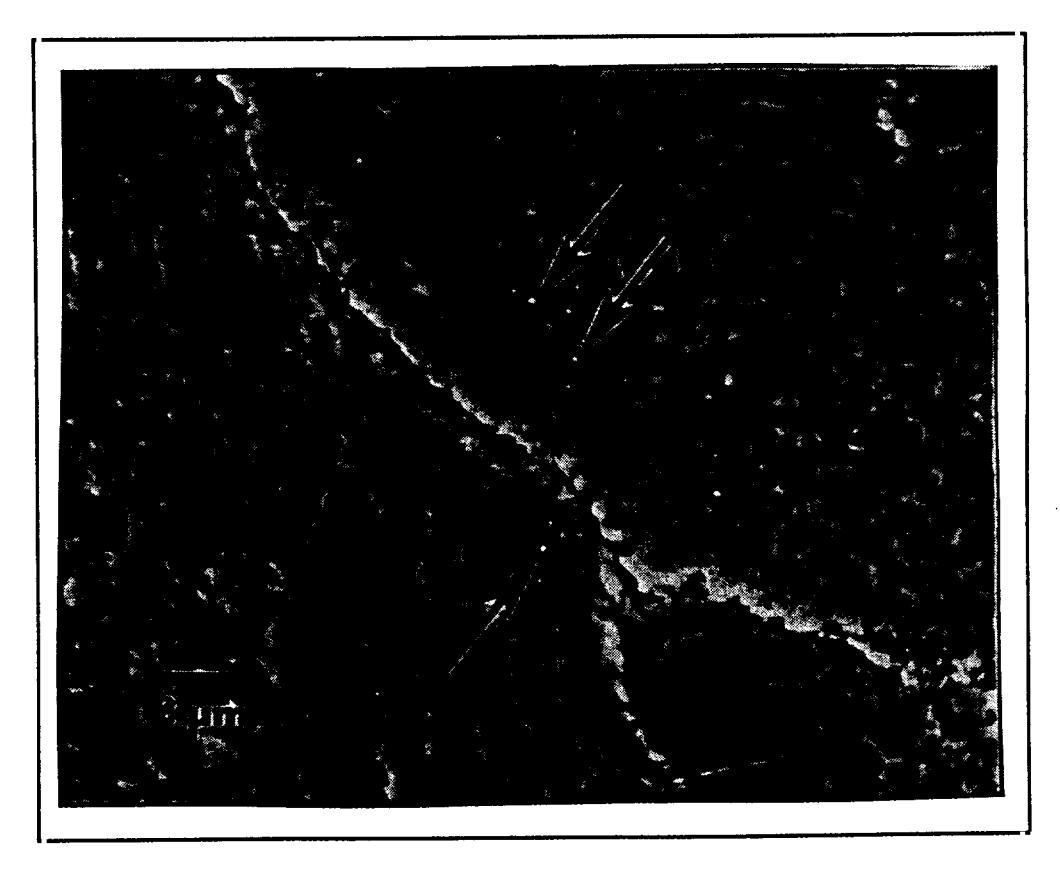
Figure 2.

Scanning Electron Micrograph of GALFAN Coating Surface. Matching Edges indicate cracks rather than grain boundaries. Small bright particles on either side of boundary are impurities.

Figure 2 shows a crack at the eutectic nodule boundary with which Lehigh has been able to identify a number of white spots. These spots represent evidence of impurity segregation at the cracks and the dents and are in fact lead particles. This is confirmed by the results of analytical work shown later.

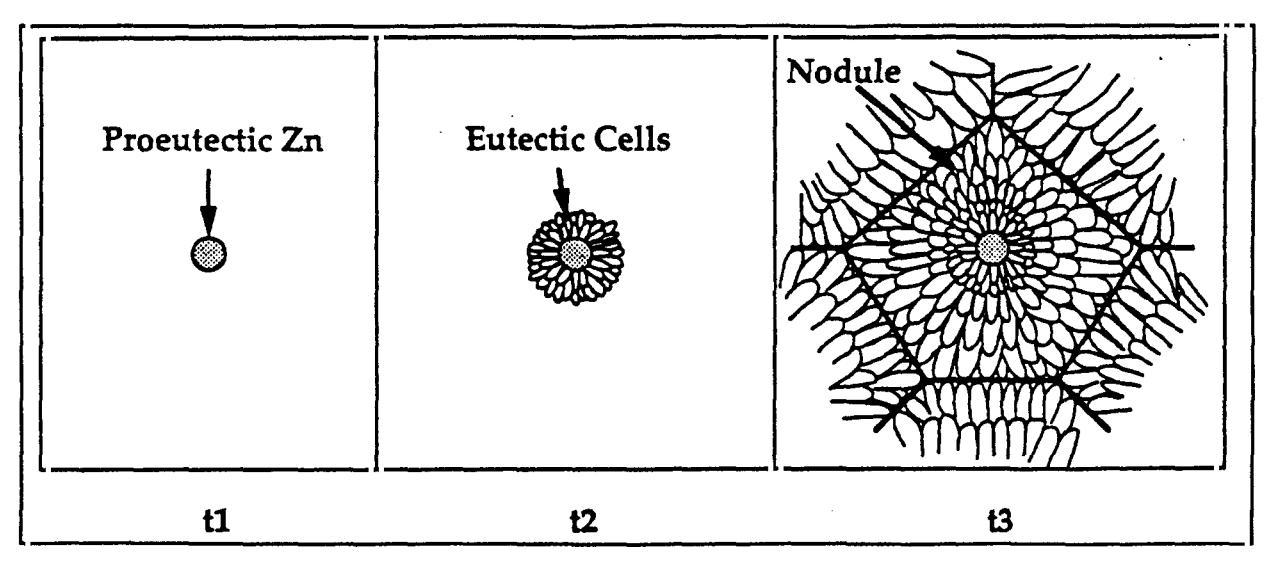
Figure 3. Schematic illustration of GALFAN development from a surface view.

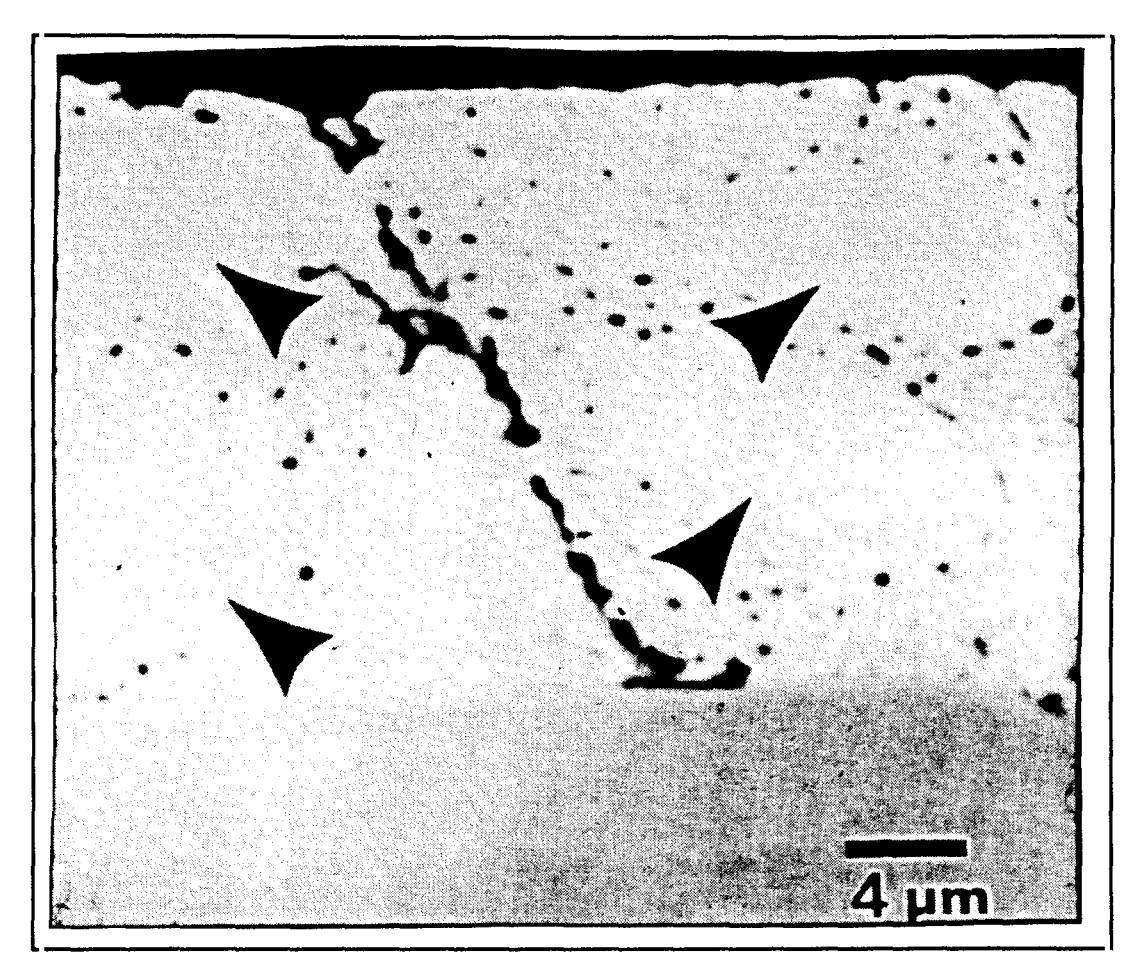
Figure 4. GALFAN Cross-Section Showing Cracks and Primary Zinc (arrows).

shrinkage and cracking is observed in zinc-aluminium castings and also in Galfan. Consequently, cracking in Galfan may be expected to occur at the primary dendrite/eutetic boundary as shown in Figure 4 where a crack is observed running from the Galfan/steel interface to the surface of the Galfan between the eutectic primary zinc rich dendrites.

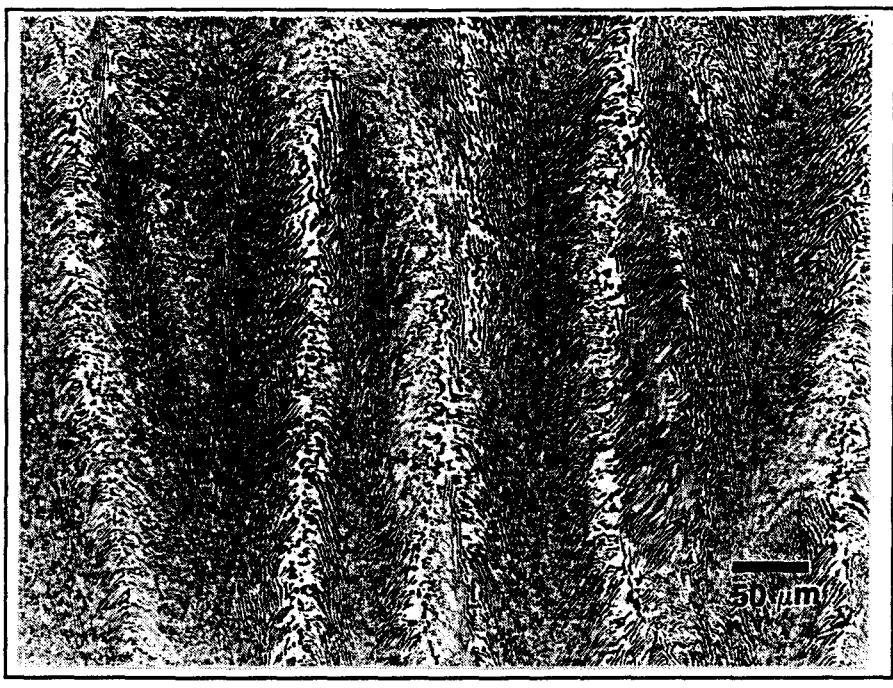
Figure 5. Eutectic cell formation during the directional solidification of the GALFAN alloy.

The third aspect of the Lehigh work involves a series of experiments which were carried out to determine the effects of directional solidification and alloy growth rate on the microstructural characteristics of the alloy. In these experiments, Galfan alloy at 4.9% aluminium was cast into 4 mm diameter rods and solidified in a vertical direction. Figure 5 shows the Galfan microstructure with the typical eutectic cell formation that may be associated with directional solidification. In connection with Figure 5 the schematic representation of alloy growth shown in Figure 3 should be borne in mind. The inter-lamellar spacings were found to be between 2.1 and 1.2 microns, for growth rates of between 18.6 and 112 microns per second which are shown to agree quite well with the data that has been produced by previous investigators. Figure 6 shows interlamellar spacing plotted against growth rate in microns per second with the Lehigh results given at the slow cooling rates. In Figure 7 the distance between the cells is plotted against growth rate. As expected the intercellular spacing decreases as the growth rate increases.

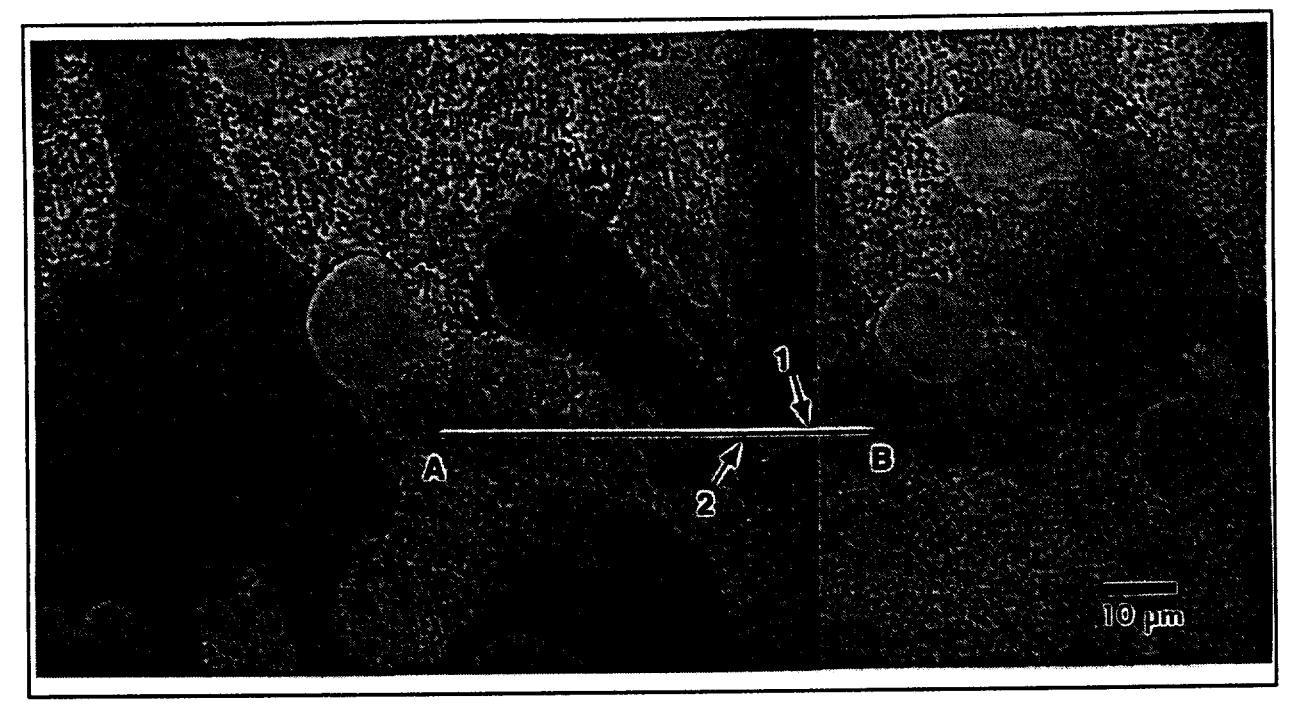
Figure 11a. Polished Galfan surface used for EPMA analysis. The line represents the analysis path, starting at "A" and ending at "B".

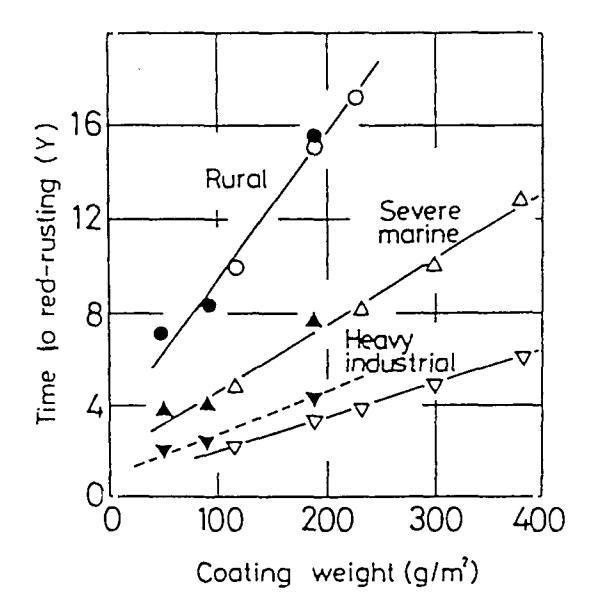
- Fig. 1 Effect of coating weight on corrosion performance of hot-dip galvanized steel sheet("Pentite B").
 - Data by ASTM, A-5 Committe Data by Nisshin Steel

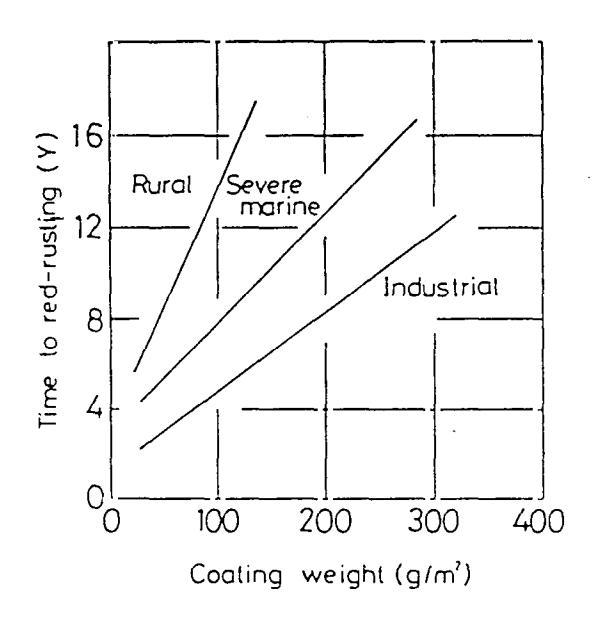
Fig. 3 Life estimation to corrosion of "Galtite" (5%Al-Zn) in various environments.

- (4) From the results of 7-year exposure testings, we got the corrosion resistance ratio of "Galtite" to "Pentite B" in various environments as follows:
 - . Rural environment 2.04 times
 - . Industrial environment 2.07 times
 - . Severe marine environment 2.16 times

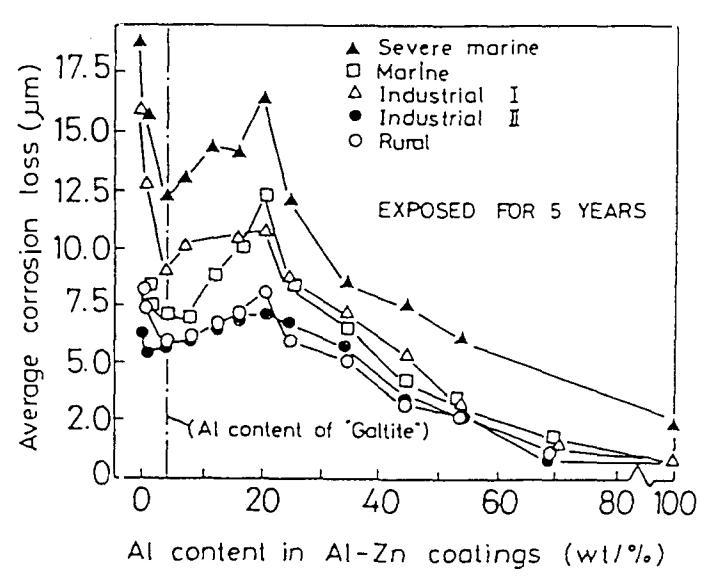
- Fig. 2 Effect of Al content on corrosion performance of Al-Zn alloy coatings after 5 years' exposure.
 - + J.B.Horton:Corrosion control by Coatings,Science Press, (1987),59

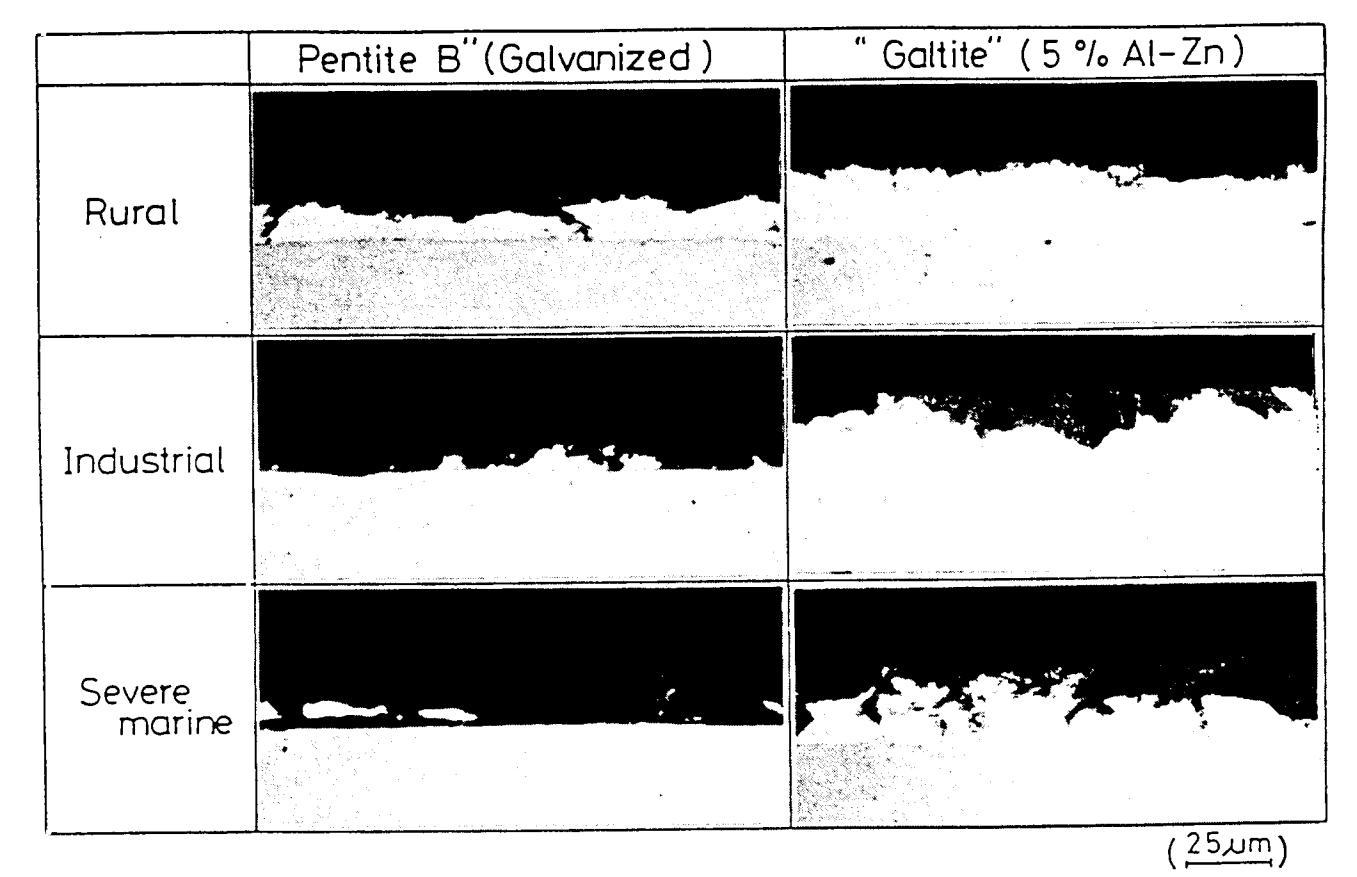
Fig.5 Cross-sectional microstructures of "Galtite"(5%AI-Zn) and "Pentite B"(Galvanized) sheets exposed for 7 years in various environments.

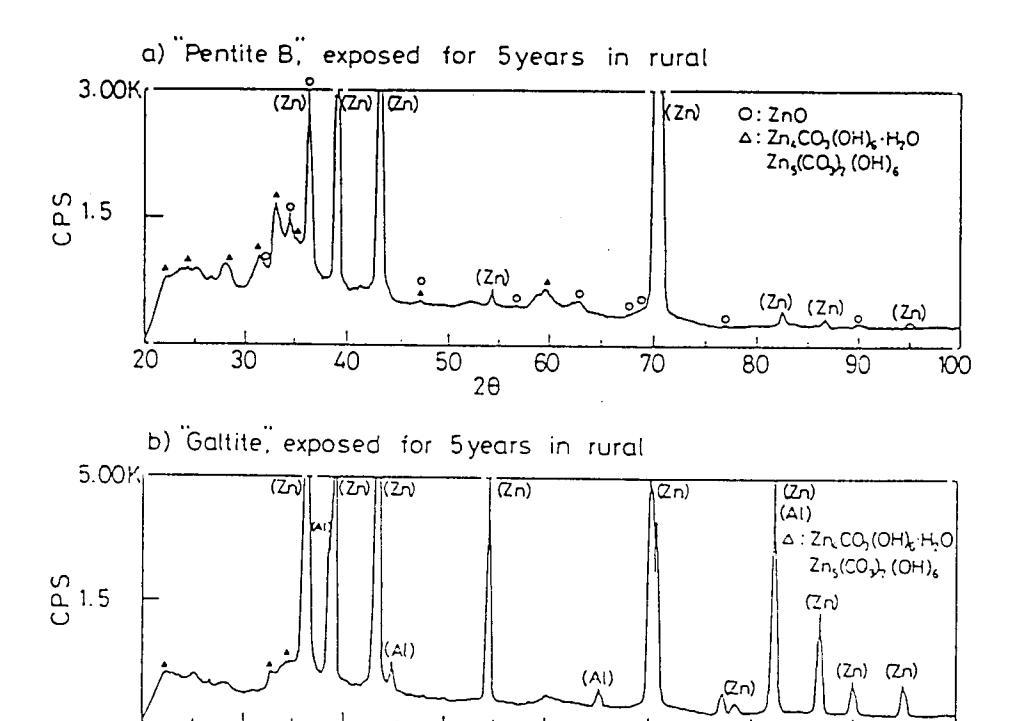
Fig.7 Corrosion products formed on "Galtite" and "Pentite B" sheets in rural environment.

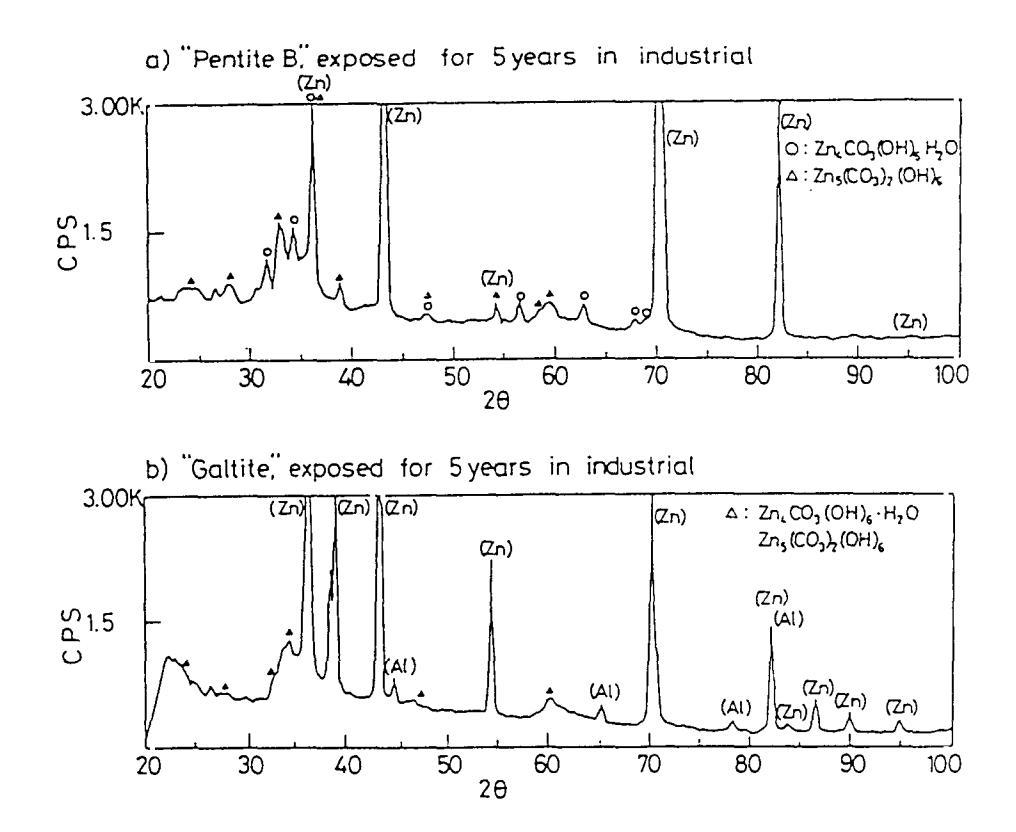
Fig. 8 Corrosion products formed on "Galtite" and "Pentite B" sheets in industrial environment.

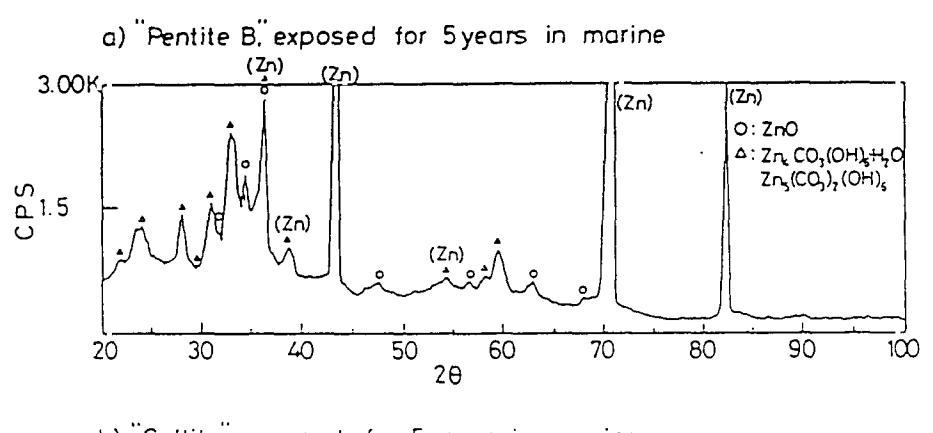
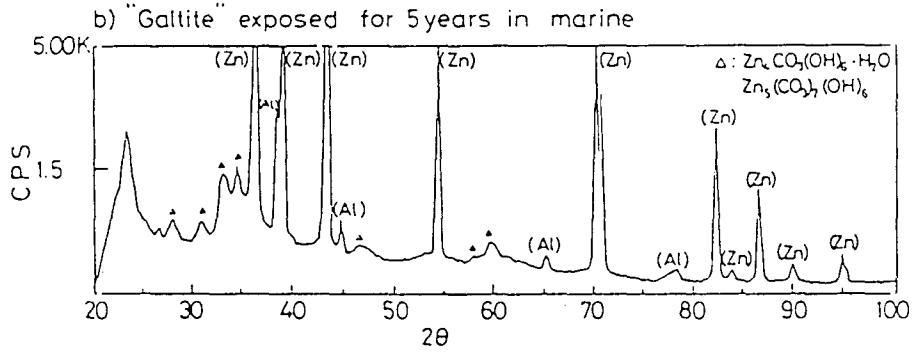
Fig. 9 Corrosion products formed on "Galtite" and "Pentite B" sheets in marine environment.

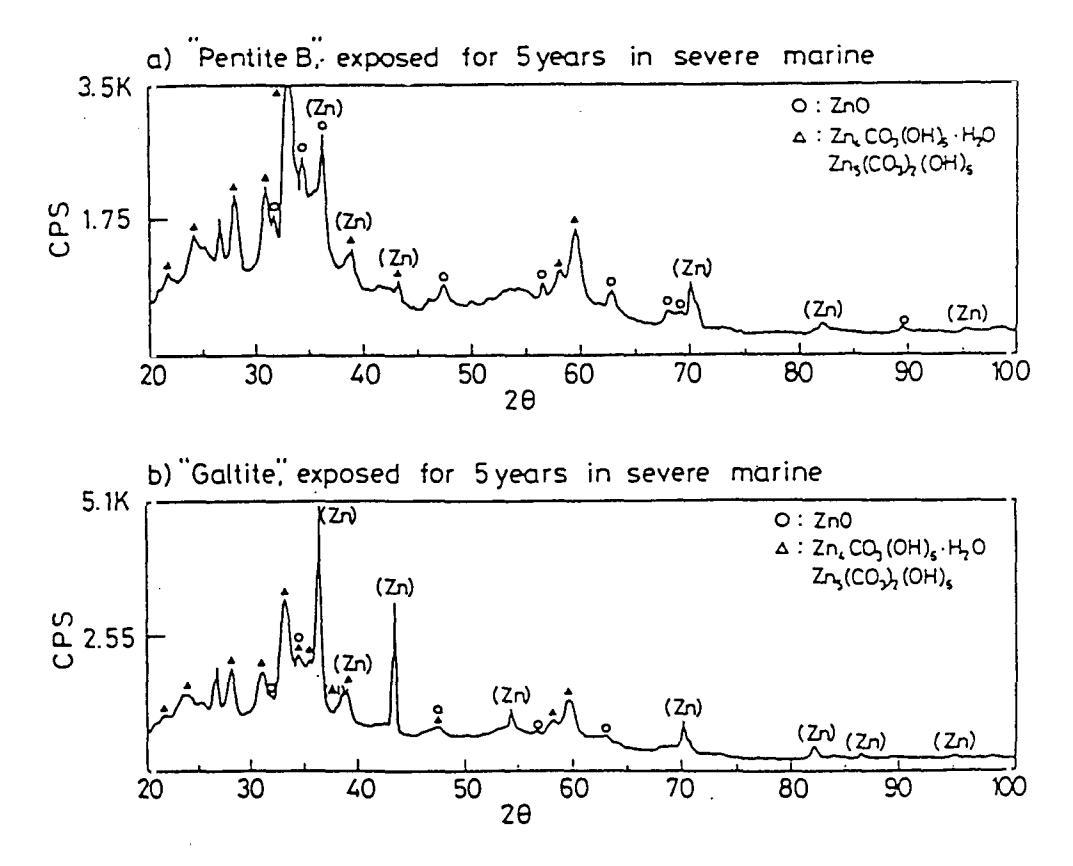
Fig.10 Corrosion products formed on "Galtite" and "Pentite B" in severe marine.

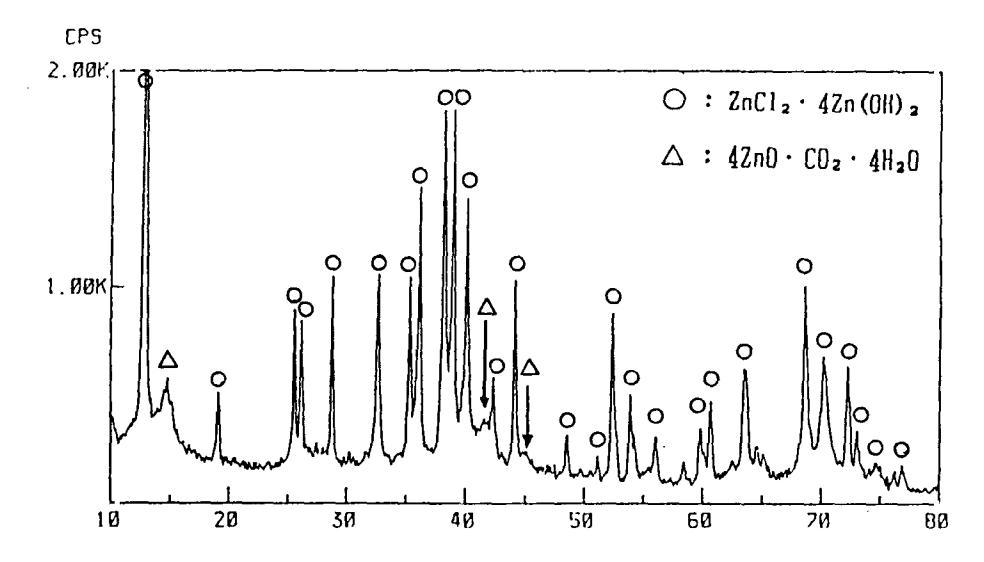
Fig. 5 X-ray diffraction of SST corrosion product (prepainted GI and GF)

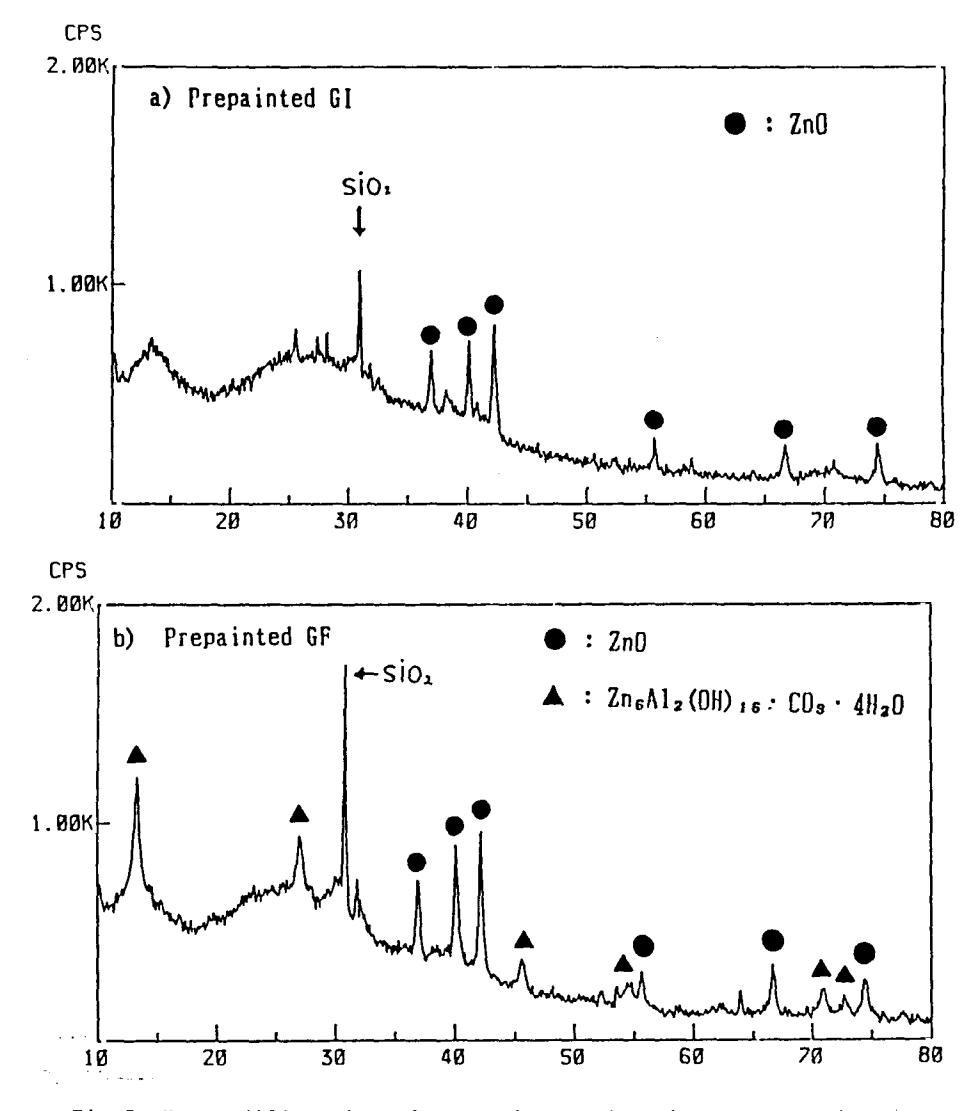
Fig. 6 X-ray diffraction of corrosion product in severe marine district exposure test

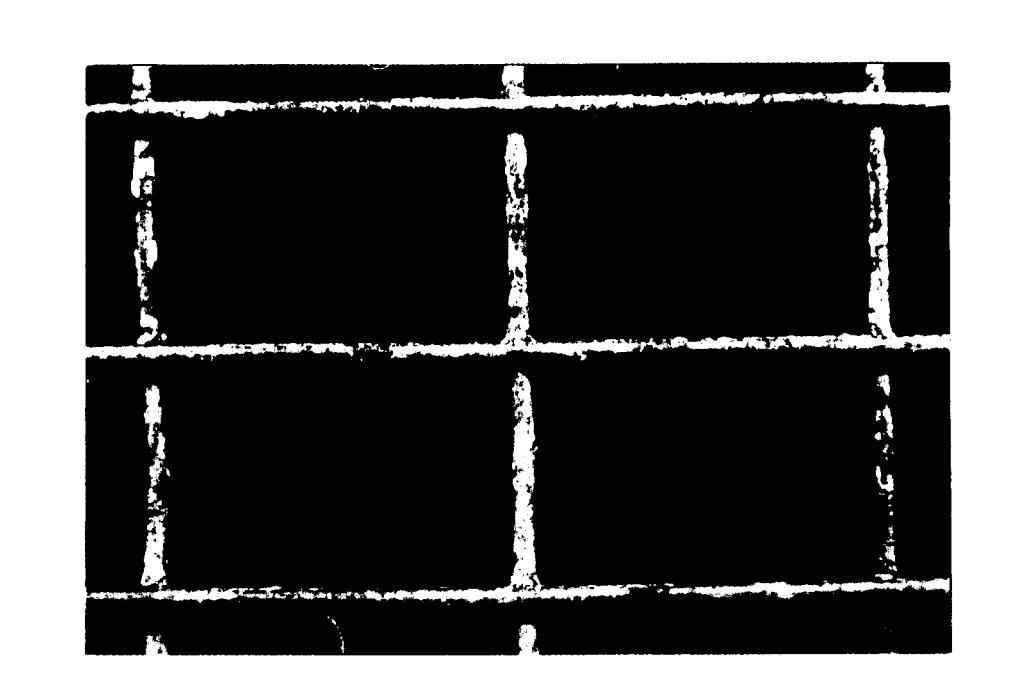
Fig. 34: Zinc-coated welded fence (25 x 40 mm) after 35 cycles SO2-atmosphere testing with locally heavy corrosion of weldings the wire

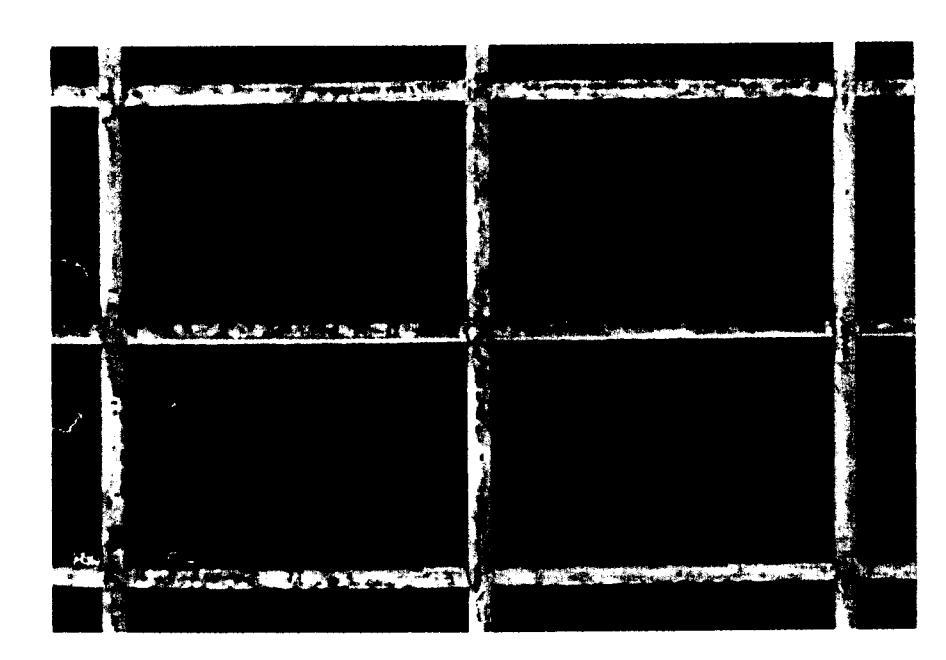
Fig. 35: Galfan-coated welded fence (25 x 40 mm) after 35 cycles SO2-atmosphere testing; no significant corrosion attack of weldings and wire

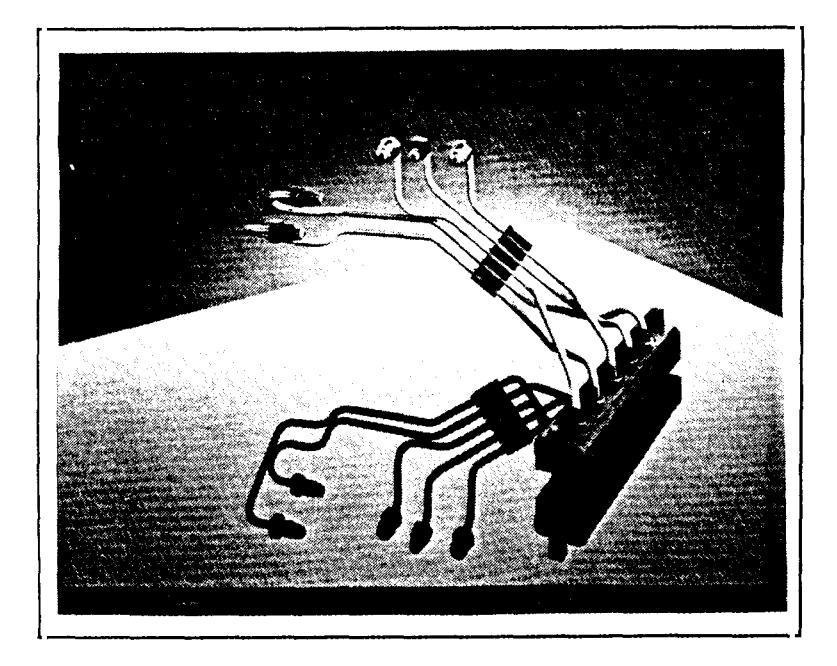
A Fabricated Tubing Cluster

Galfan's greater ductility allows the severe bending and swaging without compromising corrosion resistance. Some clusters are much longer and may include tubes carrying various fluids, wiring, hoses, filters, connectors, etc.

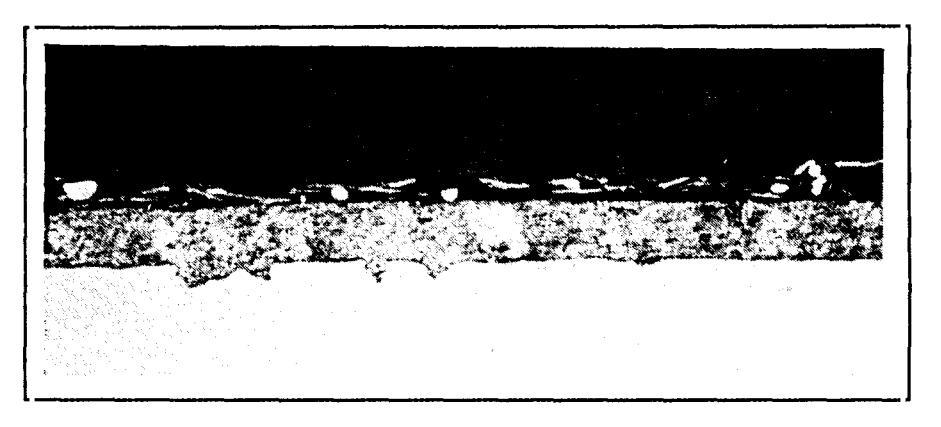
Section of Al-rich epoxy painted Galfan-coated steel tubing. 600x Courtesy: Cominco, Ltd.

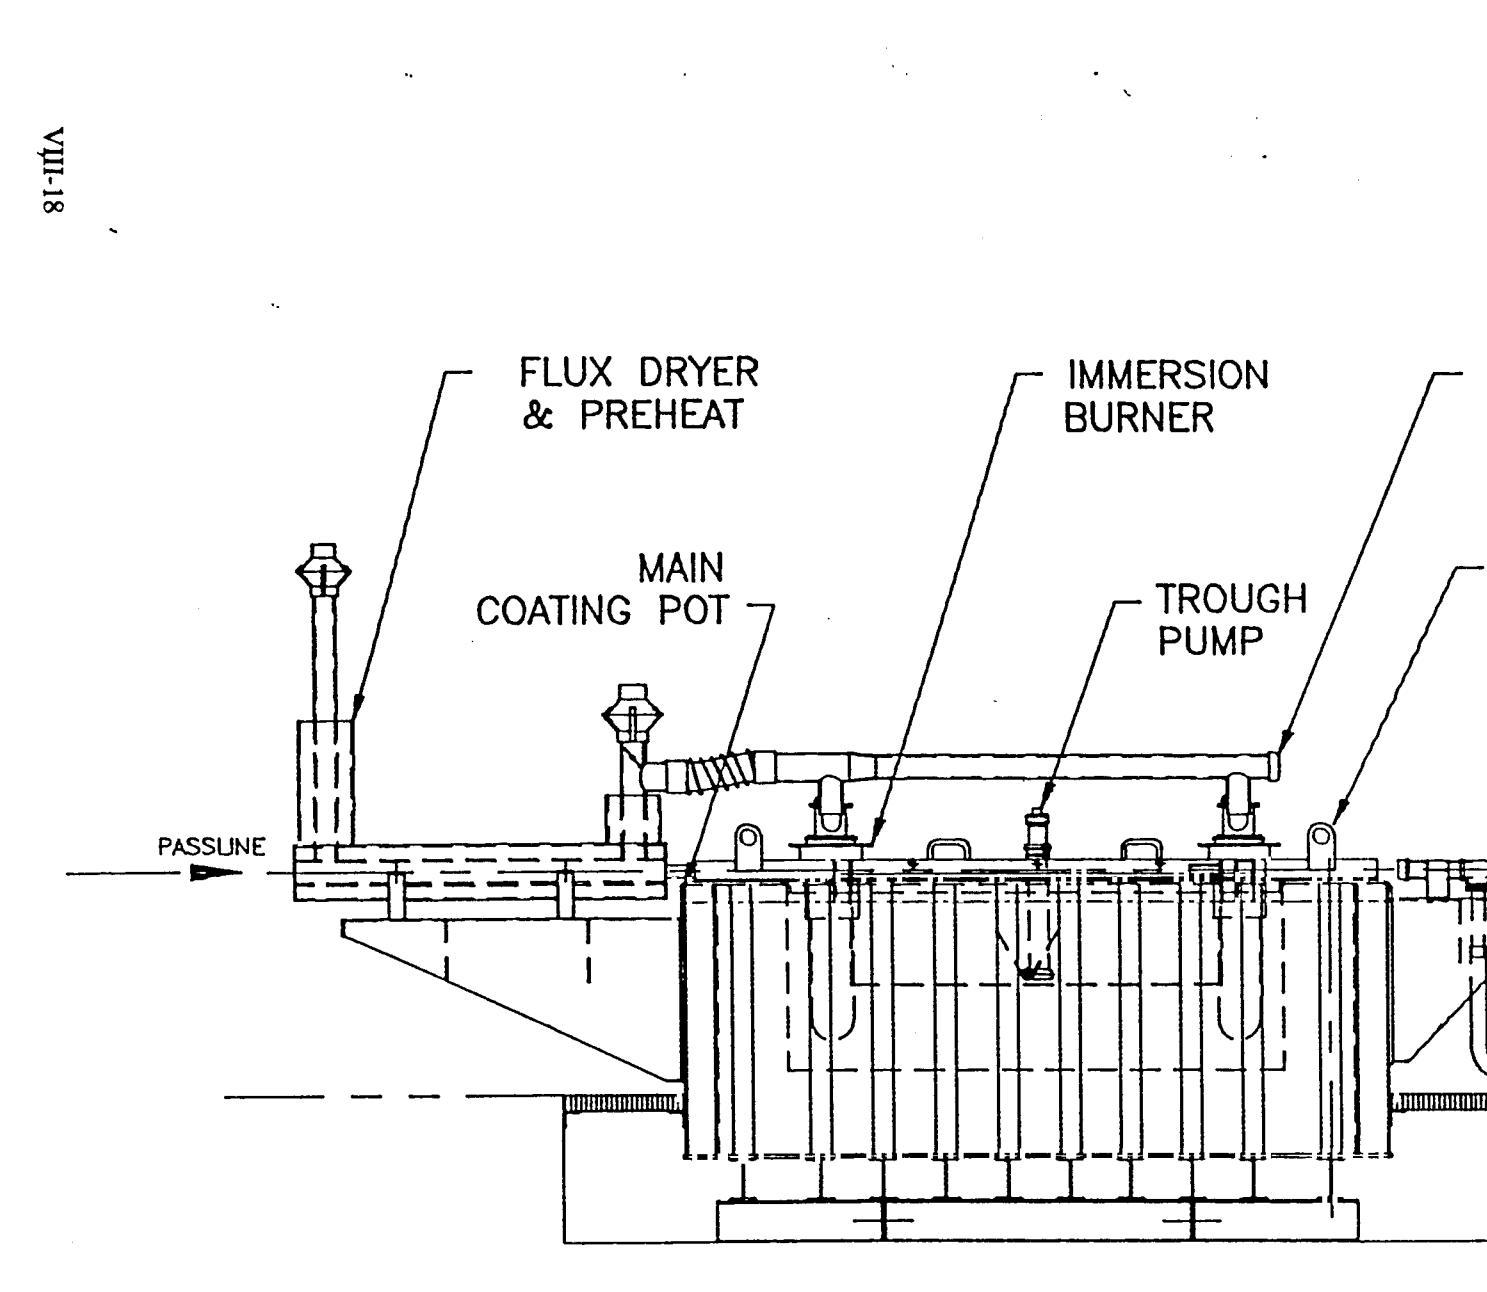
OPERATOR'S SIDE VIEW

IMMERSION BURNERS IMPROVE GALFAN BATH HEATING

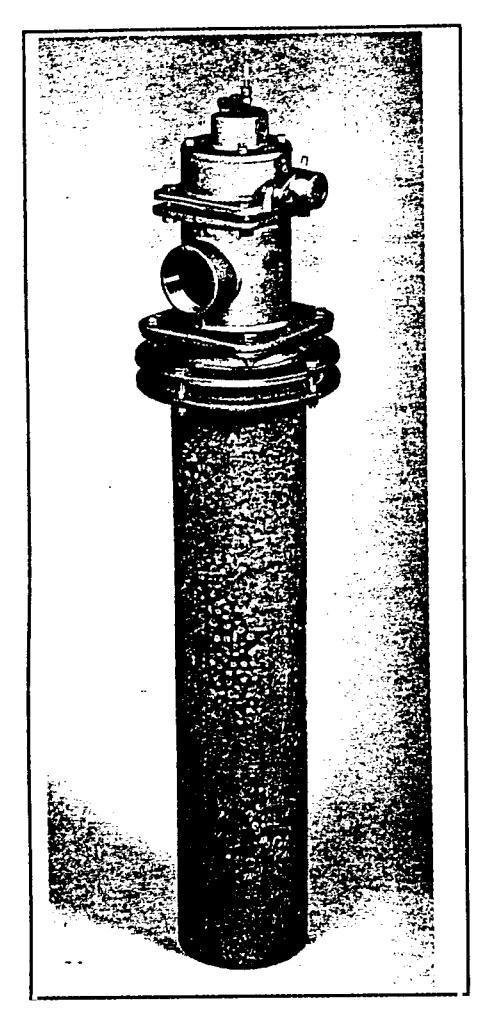
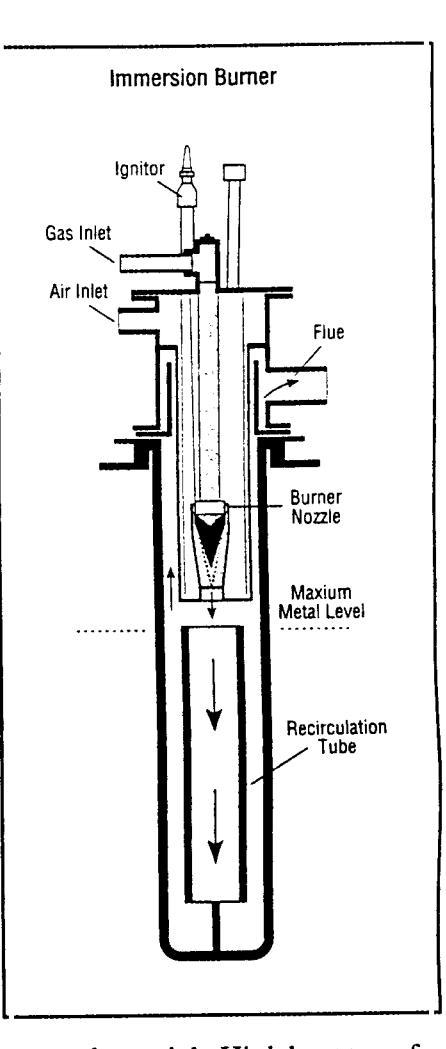
Developments in gas-fired ceramic immersion burners are benefiting aluminum and zinc processors. The ceramic tube immersion burner consists of a single close-ended outer tube, an internal recirculator tube, and a recuperative burner. They are particularly suited for the small wire and tube ceramic pots or for adding capacity to an existing pot without increasing the heat load to the kettle wall.

A new generation of gas-fired immersion tube burners, based on technology developed by British Gas in the 1970s, has found increased success over the past several years. Composed of silicon carbide, they are stable in molten aluminum and zinc, and have a high thermal conductivity.

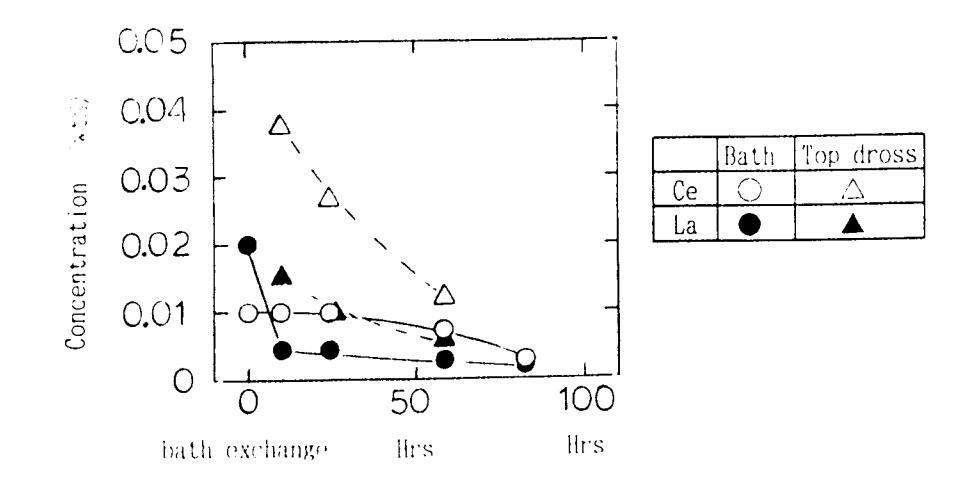
Figure 2 The concentration decrease rate of Ce and La in the top dross and the top of the regular galvanizing bath.

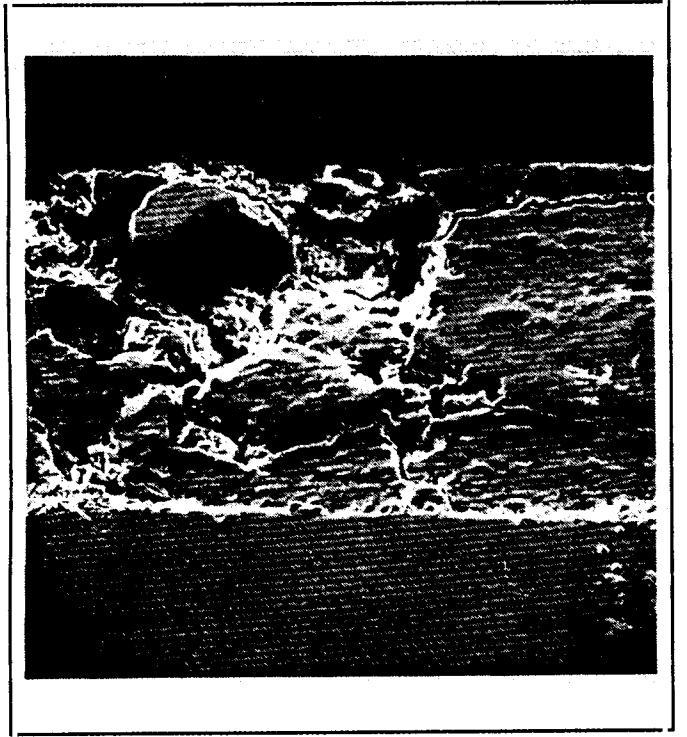
Electron photomicrograph at 200x showing a defect (cross section) which is seen to include an uncoated area. Note the thin white line of Potassium crystals near the base of the defect area.

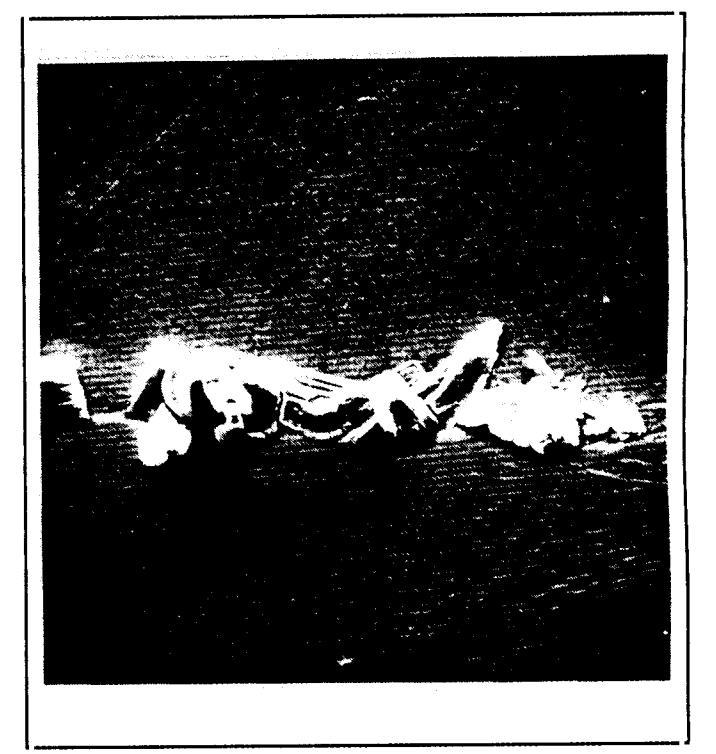
Electron photomicrograph at 1500x showing the Potassium crystal layer seen in the previous electron photomicrograph

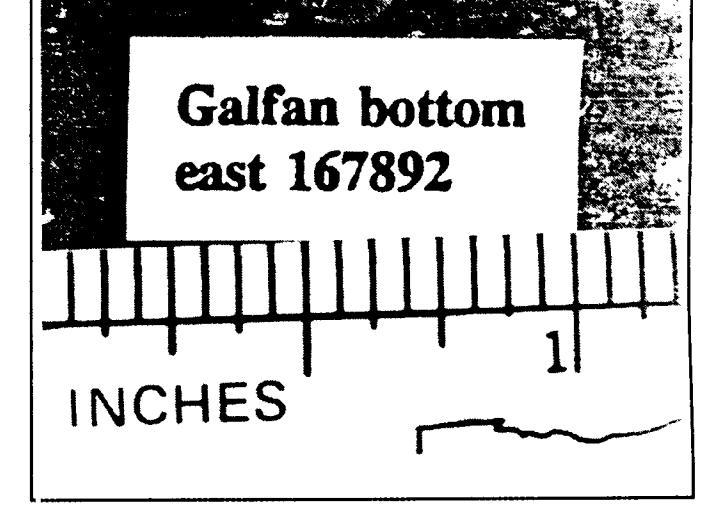
Macrophotograph of what we termed a "bullseye" defect which we believe was due to arcing from the plating cell. Center area is an oxide layer. Note the expanded circular area around the uncoated spot.

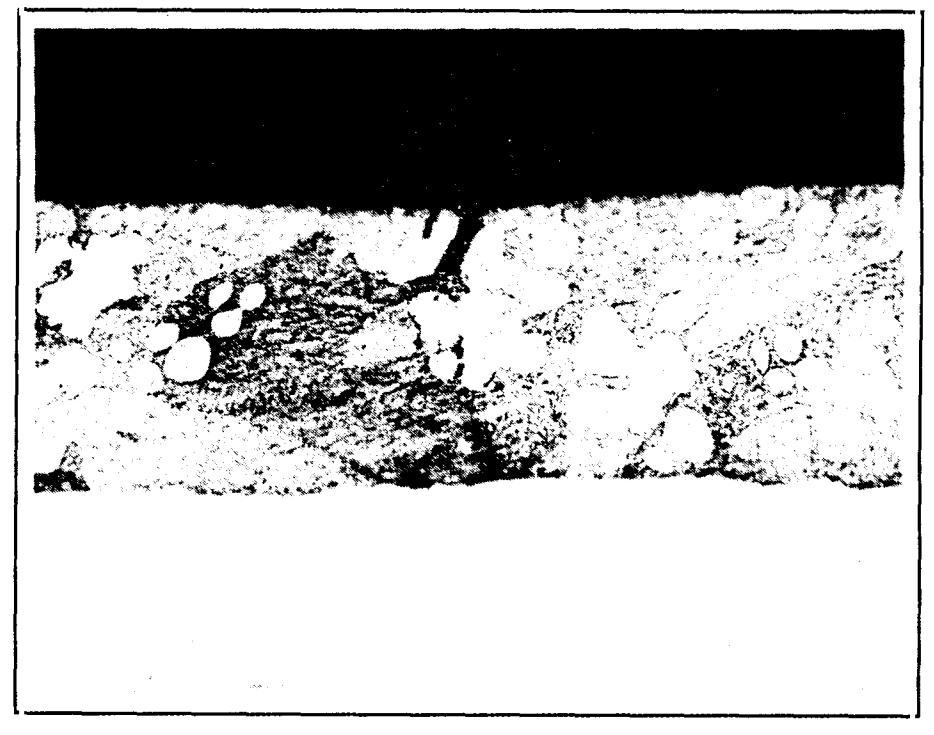
Microstructure at 1000x of the first GALFAN campaign on September 26, 1991

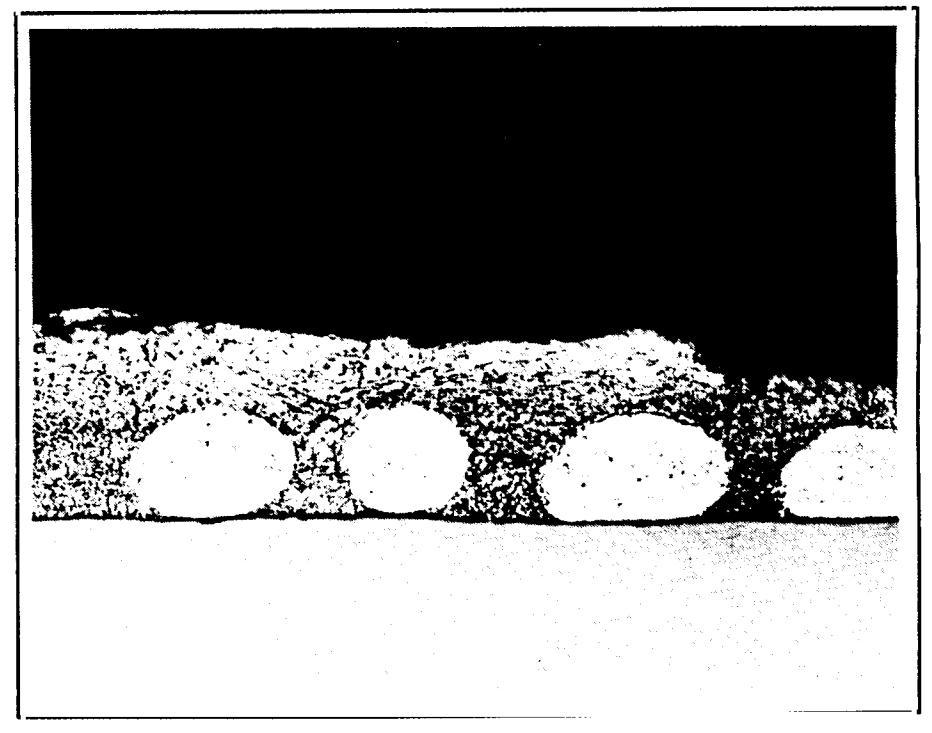
Microstructure at 1000x of the second GALFAN campaign on May 8, 1992.

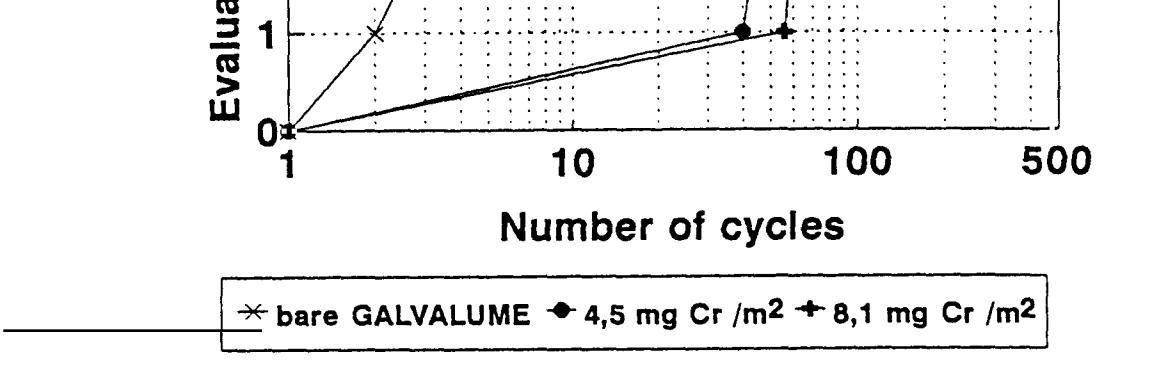
Fig. 1. Post-treatment of GALVALUME with organic chromate solutions: Influence of Cr-content on formation of white rust.
