- TO: Galfan® Licensees Galfan Licensee Meeting Attendees
- FROM: John L. Hostetler, P.E., Director Galfan Technical Resource Center
- DATE: 1 February 1993
- SUBJECT: •Minutes of 17th Licensee Meting Proceedings •Preliminary Plans for 18th Licensee Meeting

17th LICENSEE MEETING PROCEEDINGS

17th Meeting

GALFAN LICENSEES

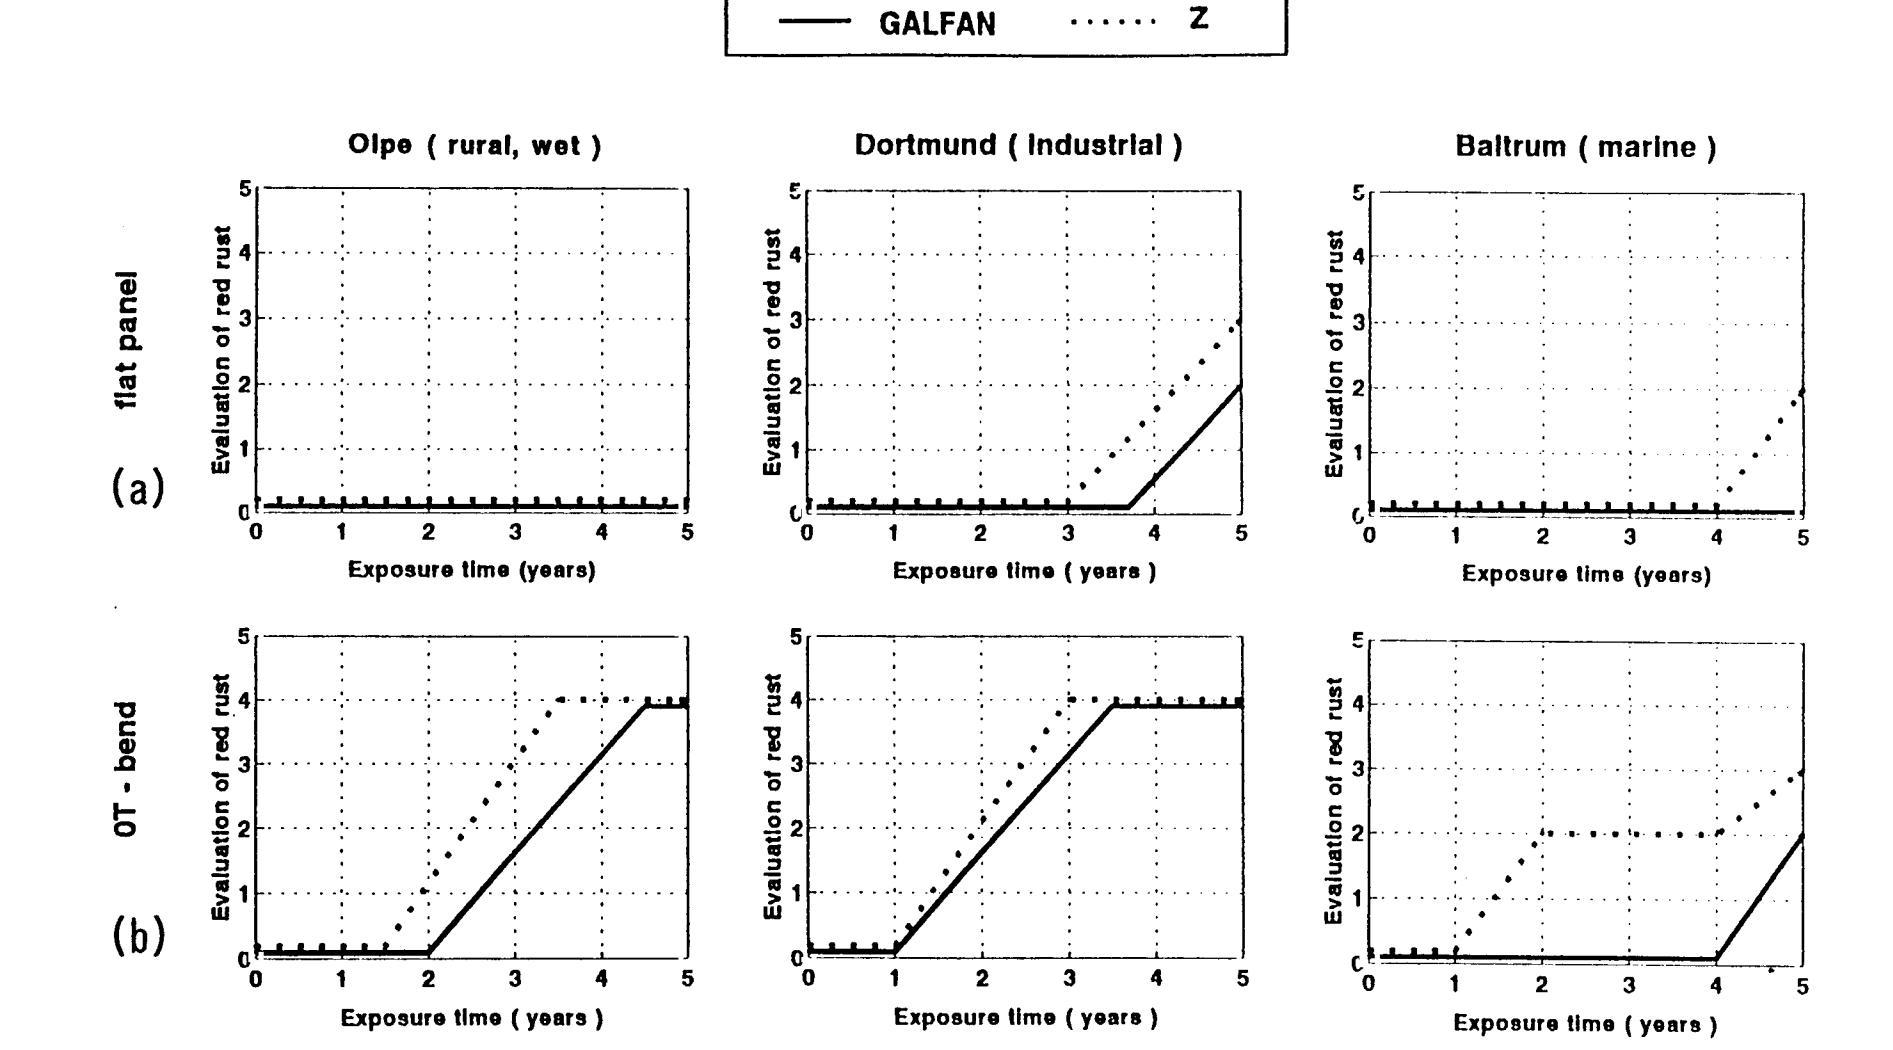
Fig. 2. Evaluation of red rust formation on prepainted GALFAN (ZA) and hot-dip galvanized steel sheet (Z) subjected to long-term atmospheric corrosion; thicknesses of the metallic coatings: 19 μm, painting: two coat system (white polyester topcoat). a) unformed panel, b) OT-bend

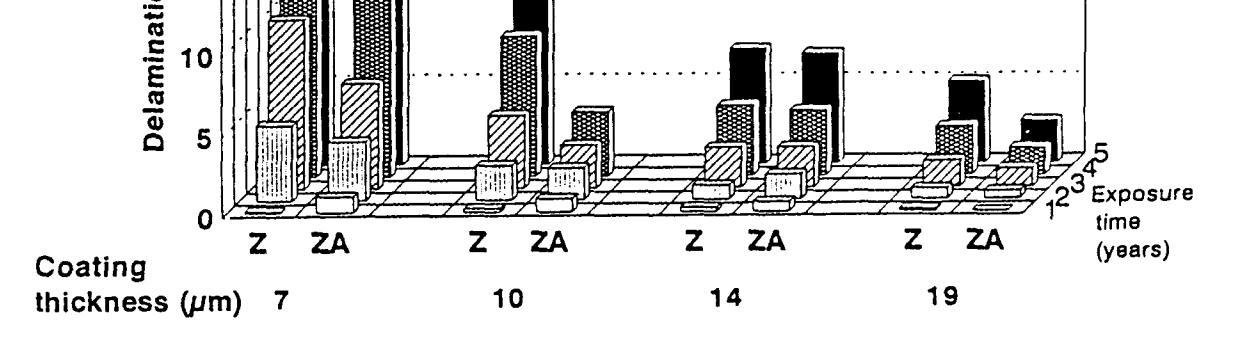
Fig. 3. Long-term atmospheric corrosion of GALFAN (ZA) and Z: Paint delamination at scribes down to the steel substrate.

The data presented in Fig.3 indicate that paint delamination at scribes down to the steel substrate on GALFAN is significantly less marked as compared to Z, independently of the atmosphere. The reason of GALFAN being favourable compared to Z may be due to higher sacrificial effect of the Z coating leading to locally accelerated dissolution of zinc and thus to more marked paint delaminations.
